**Test N2 2"x14" Steel Bodied Generators for Heat Transfer and Maximum Single-Nozzle Jet Pressure Generated to Evaluate Possible Stress on Nearby External Structural Components Using the Boeing Test Stand.**

**N2T2013-0314-04**

## **Generator Pressure Screening Tests**

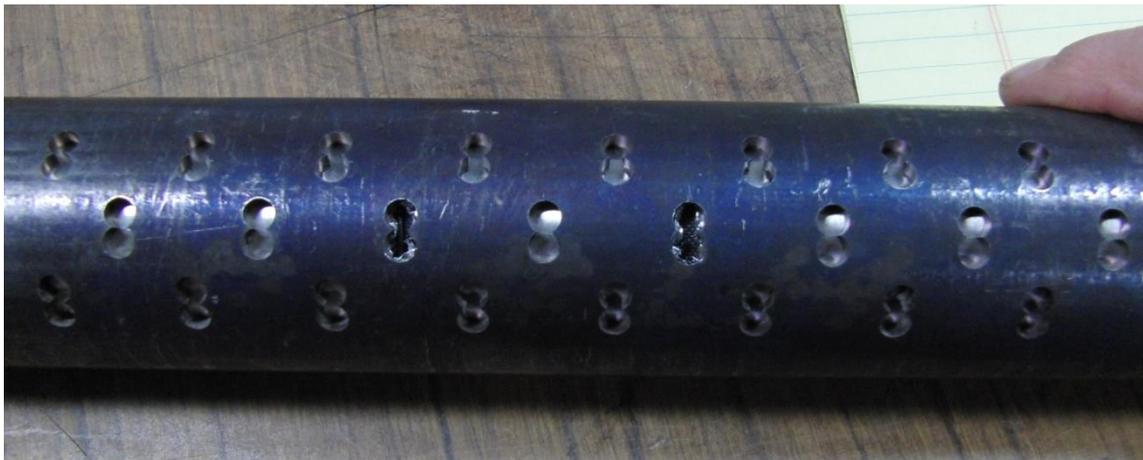
Photograph 2: Close photograph of N2 Generator before testing, showing the puncturing of the burst foil in the two nozzles to be directly in line with the two pressure transducers to be used in Test 04.

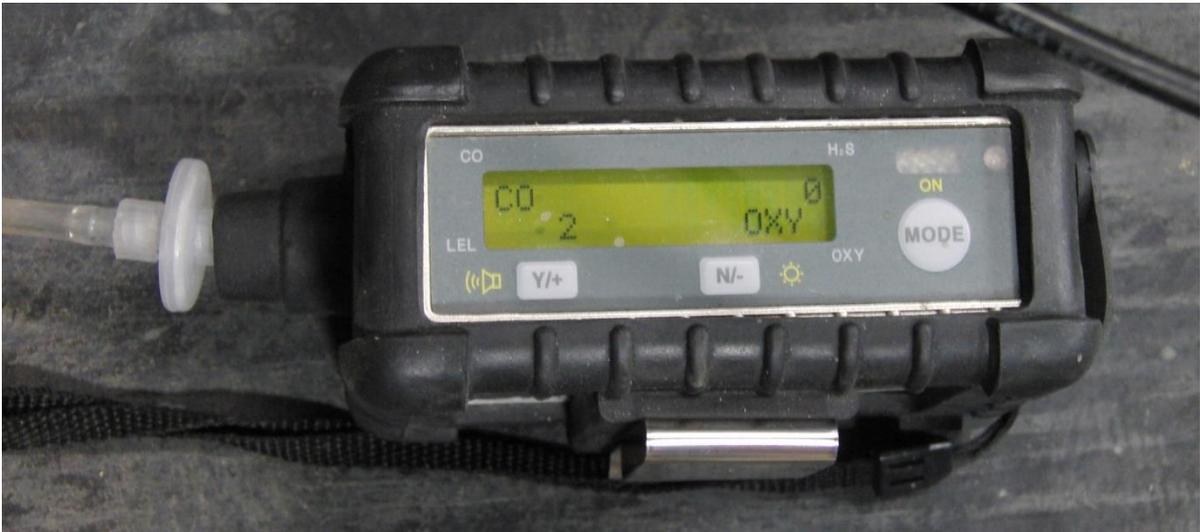
Photograph 3: Pro-Rae Multi-Gas Monitor used to monitor and record the CO and Oxygen levels during the test.

The monitoring of the levels of oxygen and carbon monoxide inside the test chamber was accomplished using a Q-RAE multi-gas monitor (Photograph

3). This monitor had the capability of measuring oxygen levels in the 0-30% range (0.1% accuracy) and carbon monoxide in the 0-1500 ppm range (1 ppm accuracy). In the generator tests, the gas monitor was operated continuously throughout each test, using a 1 second sampling rate

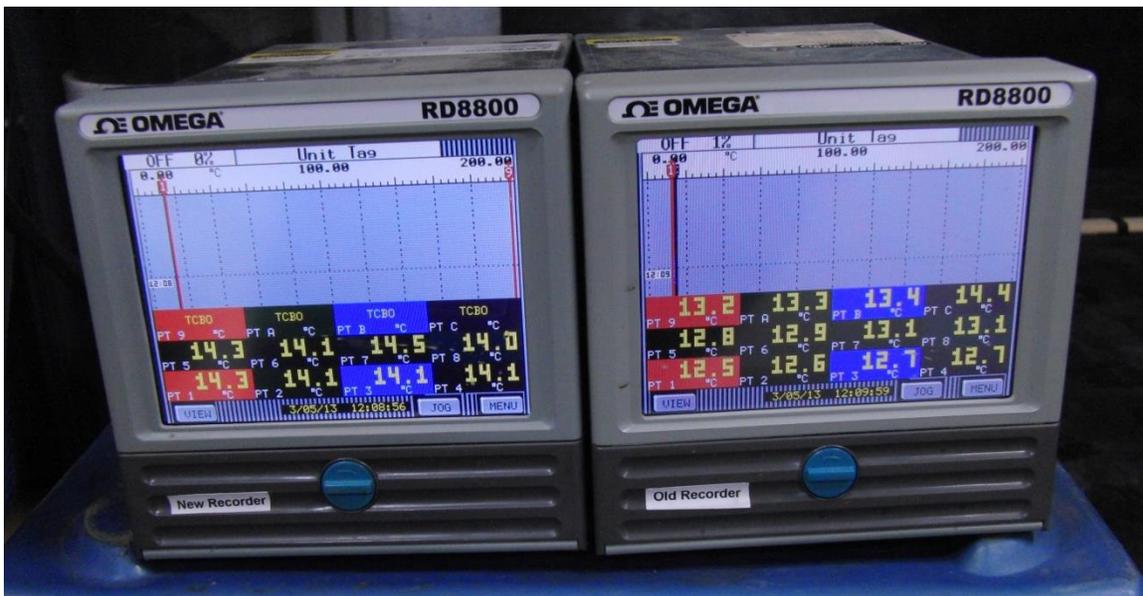
Photograph 4: Two 12 channel Omega RD8800 thermocouple data acquisition devices were used to record the temperature data.

The temperature was recorded using twenty 30 gauge Type K thermocouples attached to two Omega 8800 12 channel data recorders recording at 8 samples/second each saving the data to a 2 GB compact flash drive.

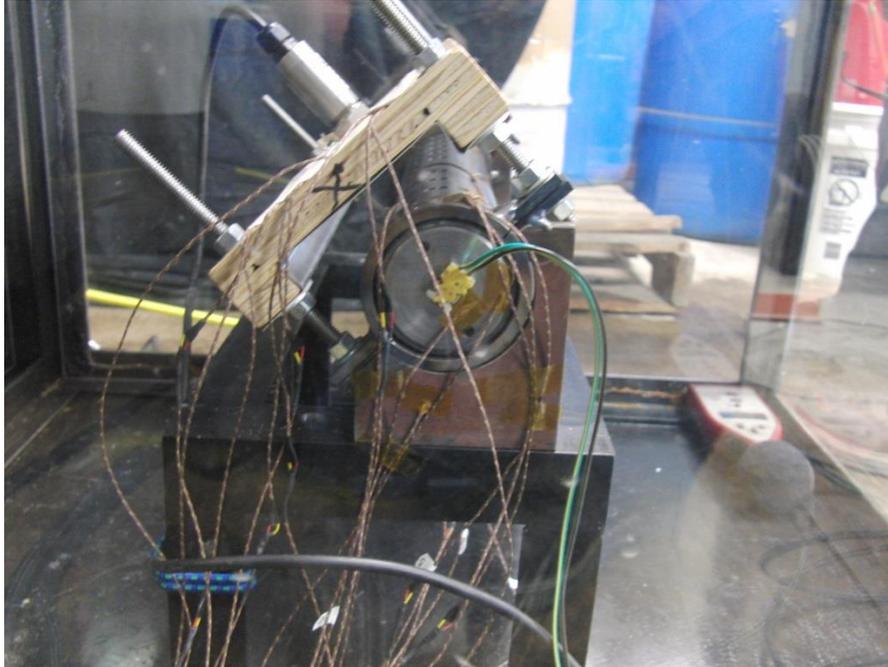
Photograph 7: Igniter end view of the test fixture showing arrangement of thermocouples and a 1 inch separation distance. The sound level meter can be seen in the front right corner of the test chamber as set in Test 02. The door opens from the bottom of the chamber to the left in this photograph.

The test set-up is shown in the attached figures 2 and 3 photographs 5-8, showing the relative positioning of the various pieces of test equipment and hardware utilized for the test. The following list describes the various pieces of monitoring equipment used in the test:
